**State of Louisiana
Coastal Protection and Restoration Authority**

**2018 Operations, Maintenance, and
Monitoring Close-Out Report**

**GIWW (Gulf Intracoastal Waterway) to
Clovelly Hydrologic Restoration (BA-02)**

State Project Number BA-02
Priority Project List 1

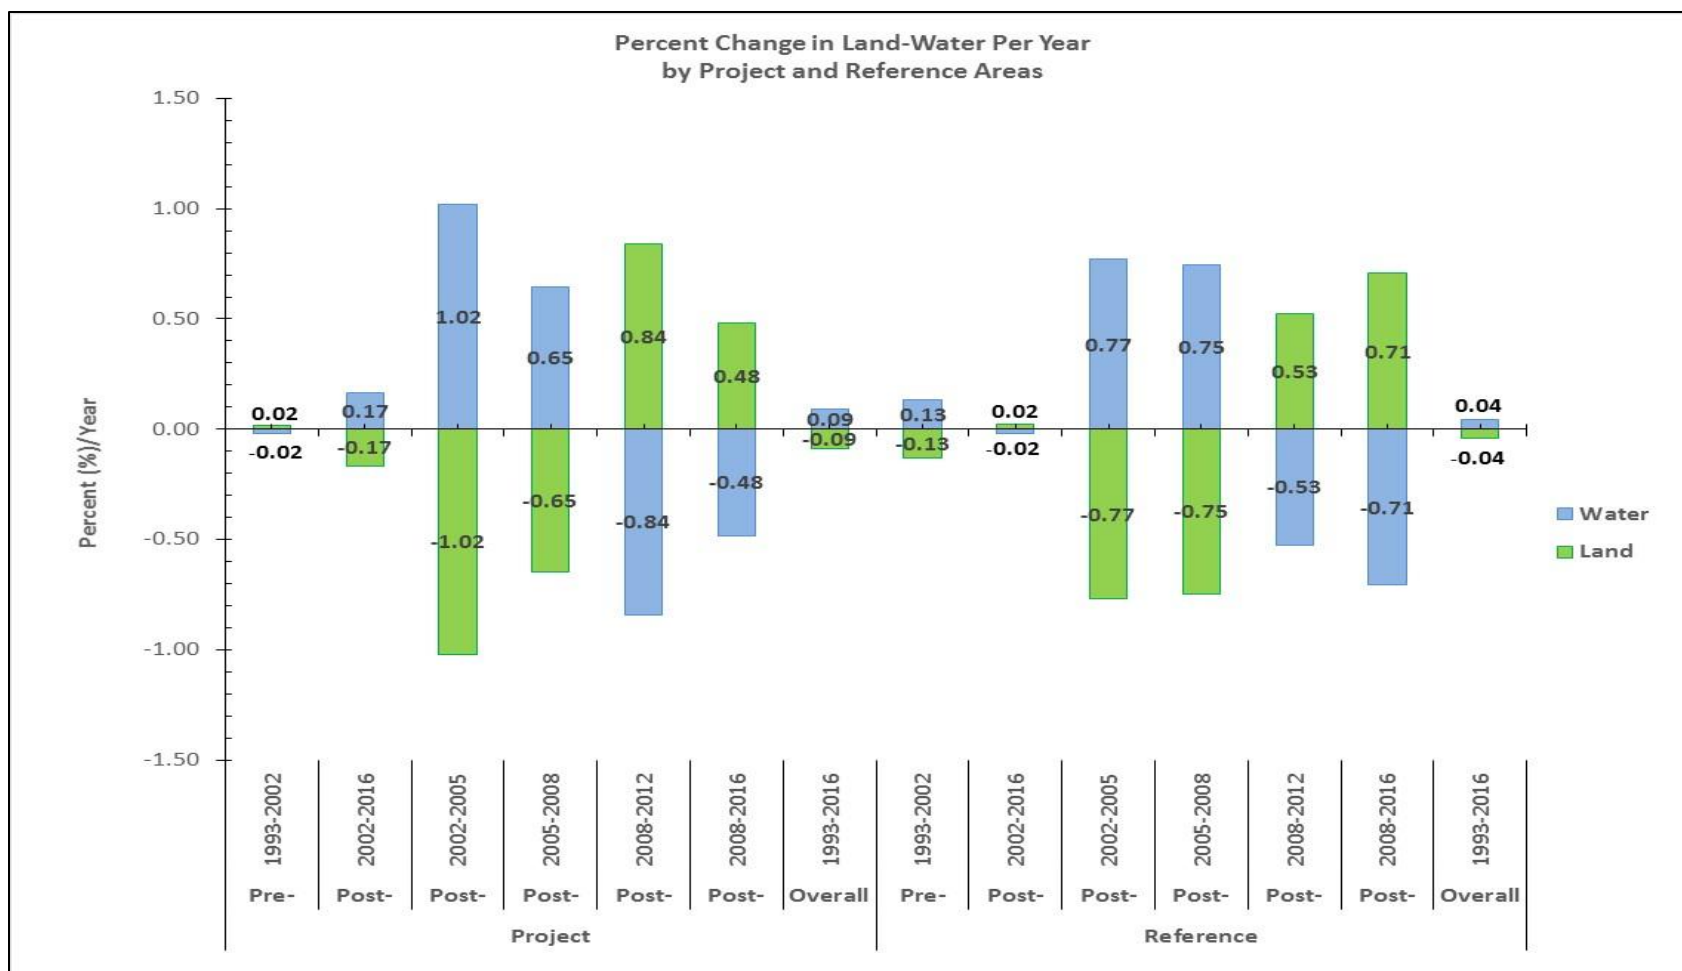
The most notable changes occurred inside both the project and reference areas between 2008 and 2012, and again from 2012 through 2016. Both areas experienced a large shift from open water to land. USGS and CPRA personnel conducted field investigations in 2016 to see if these changes were real. The investigations confirmed that the changes identified through photo-interpretation of the 2012 and 2016 imagery were accurate. The 2012 imagery was the first year without recent storm impacts from major storms. It is possible that between 2012 and 2016 land loss rates were reduced or some net stability in the loss rate was achieved due to a pause in major tropical weather system activity (B. Couvillion, USGS, per. Comm.). Additionally, during field investigations it was observed that these land changes may be due to transient floating vegetation mats expanding and attaching to existing pond edges and growing into the substrate.

Figure 3. Percent change in land-water for pre-construction, post-construction, and overall for the GIWW (Gulf Intracoastal Waterway) to Clovelly Hydrologic Restoration (BA-02) project.

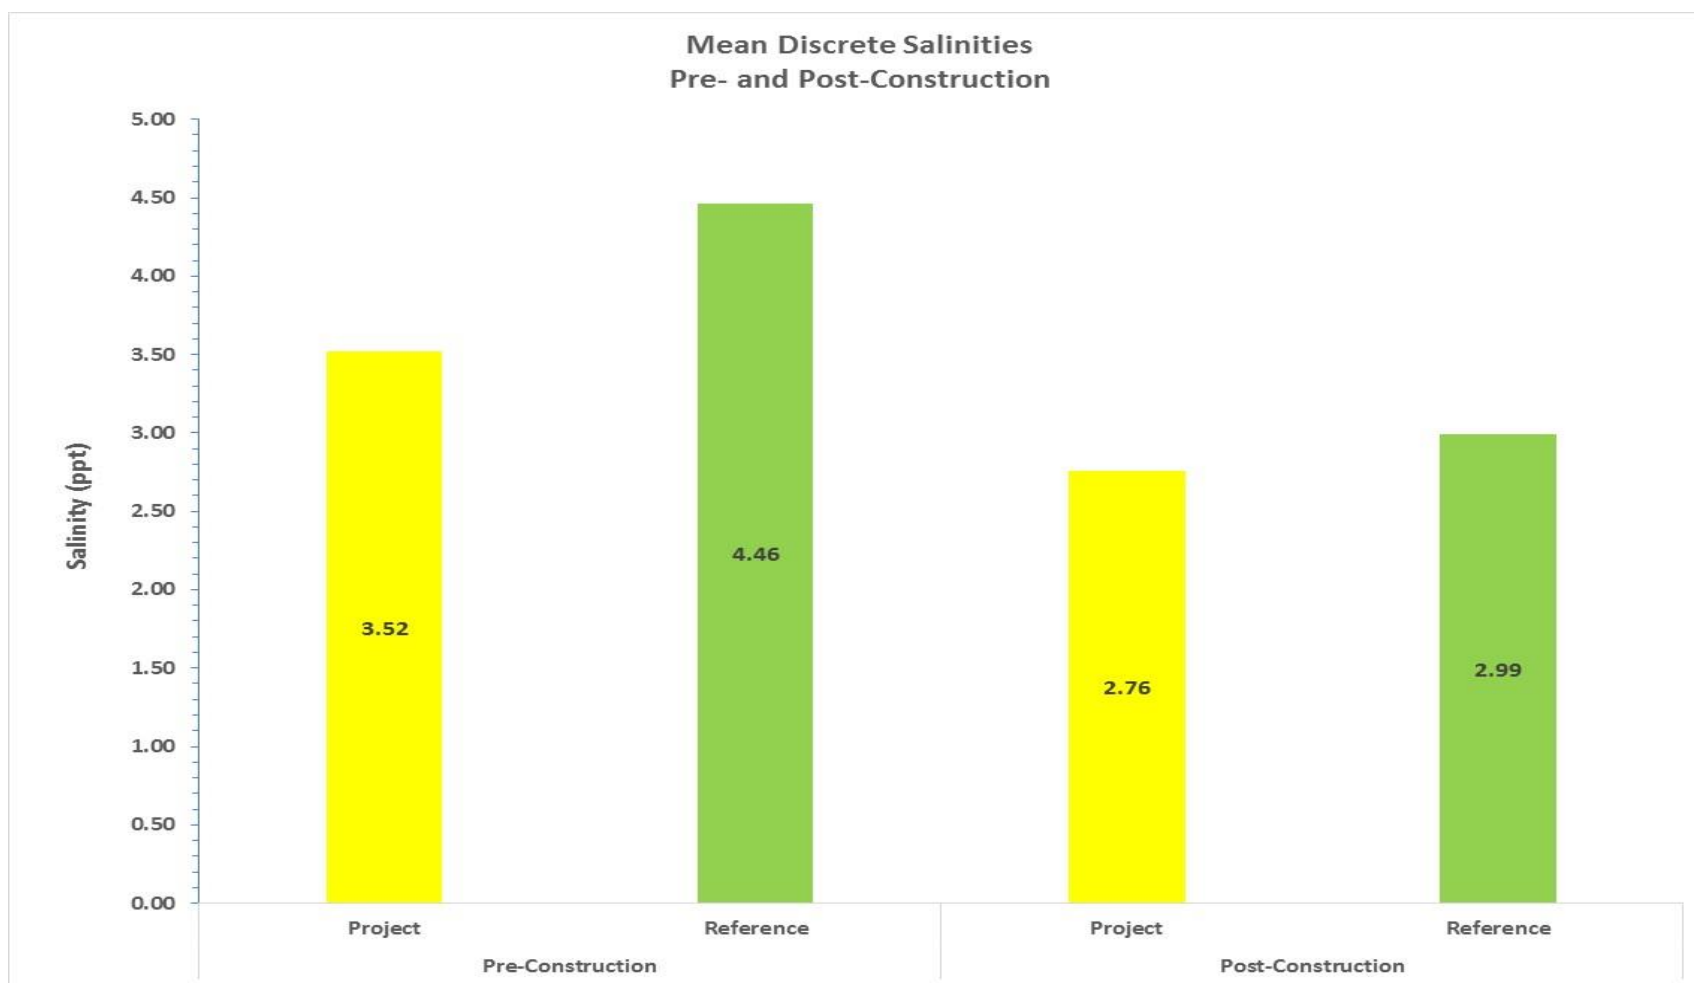
Discrete salinity data for pre-construction and post-construction are graphed in figure 10. The graphic depicts the mean bottom salinity readings for each time period. Of the fifty-two (52) discrete stations originally established, twenty-six (26) of them had data for pre-construction and post-construction time periods. Three of the stations were reference stations and twenty-three (23) were project stations. Reference stations were located immediately outside of weirs on the western rim of Little Lake. The mean discrete salinities for the project stations were lower than those of the reference stations during pre-construction and post-construction.

Figure 10. Mean discrete salinities for project and reference stations for pre-construction and post-construction at the BA-02 project.

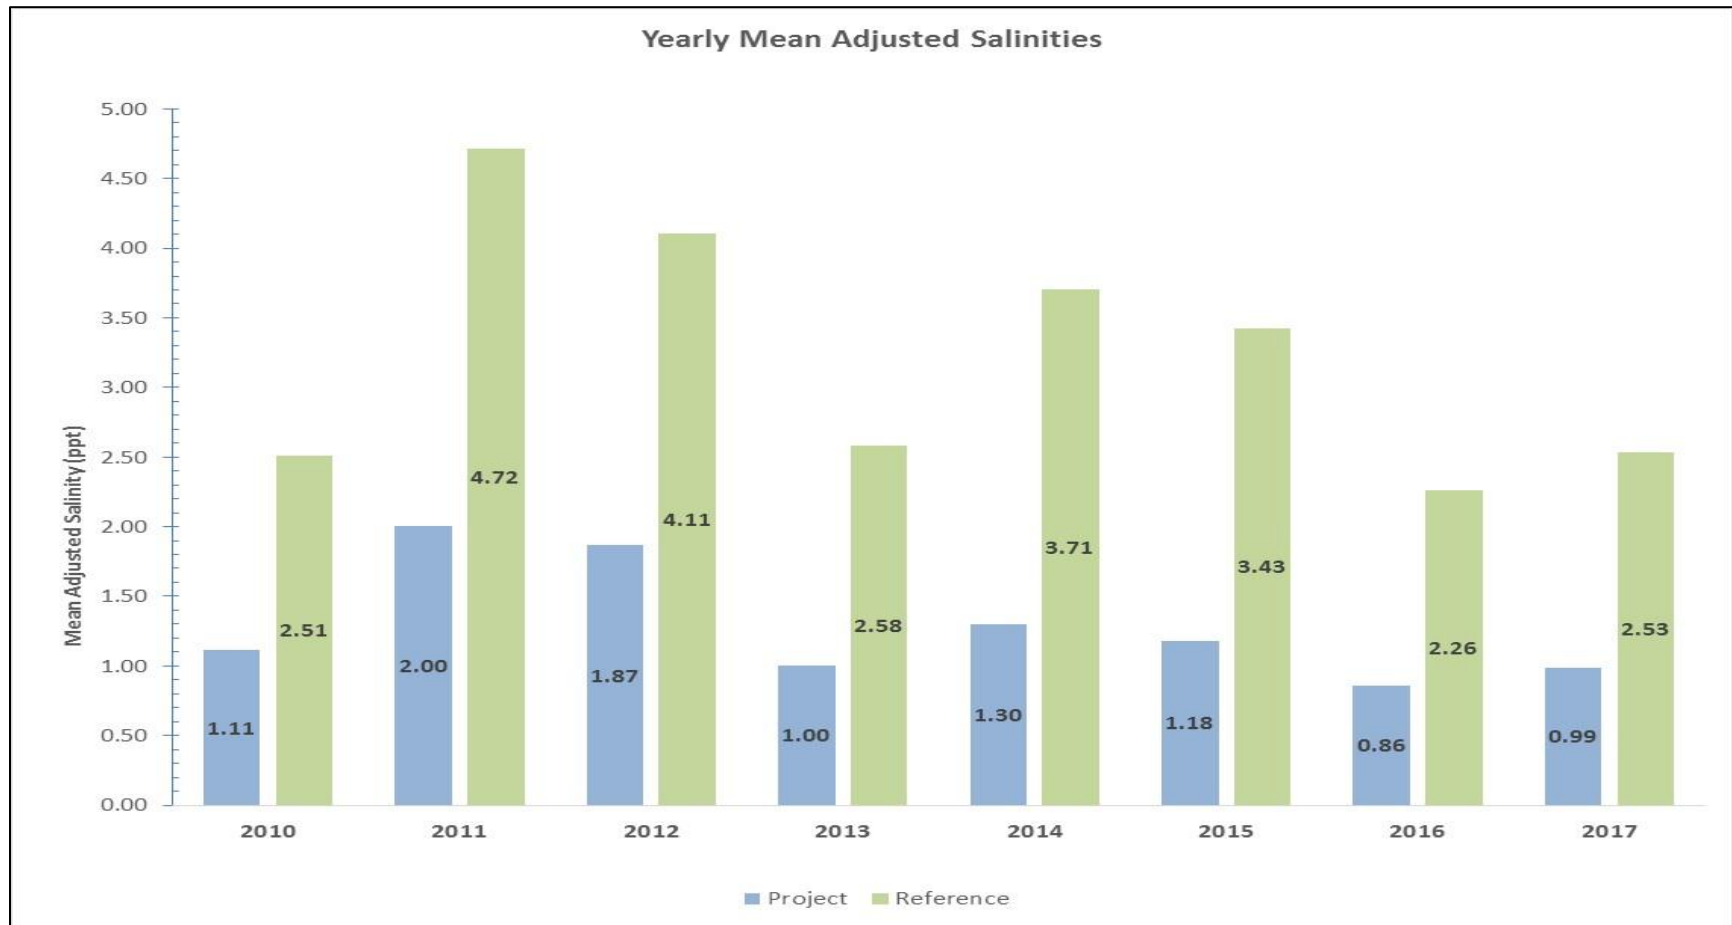
Yearly mean salinities are presented in figure 11 for all continuous recorder stations listed inside and outside of the project area. Stations were grouped by project or reference area. For this graphic, calculations were made only for the date range where all recorder stations had simultaneous data collection periods (February 26, 2010 through October 11, 2017) in JMP®, version 13. Graphs were produced in Microsoft Excel® 2010. Note that the stations inside the project boundary consistently had the lowest mean yearly salinities, at or below 2.0 ppt for the entire period of record.

Figure 11. Yearly mean salinities for all open water continuous recorder stations inside and outside of the BA-02 project area.

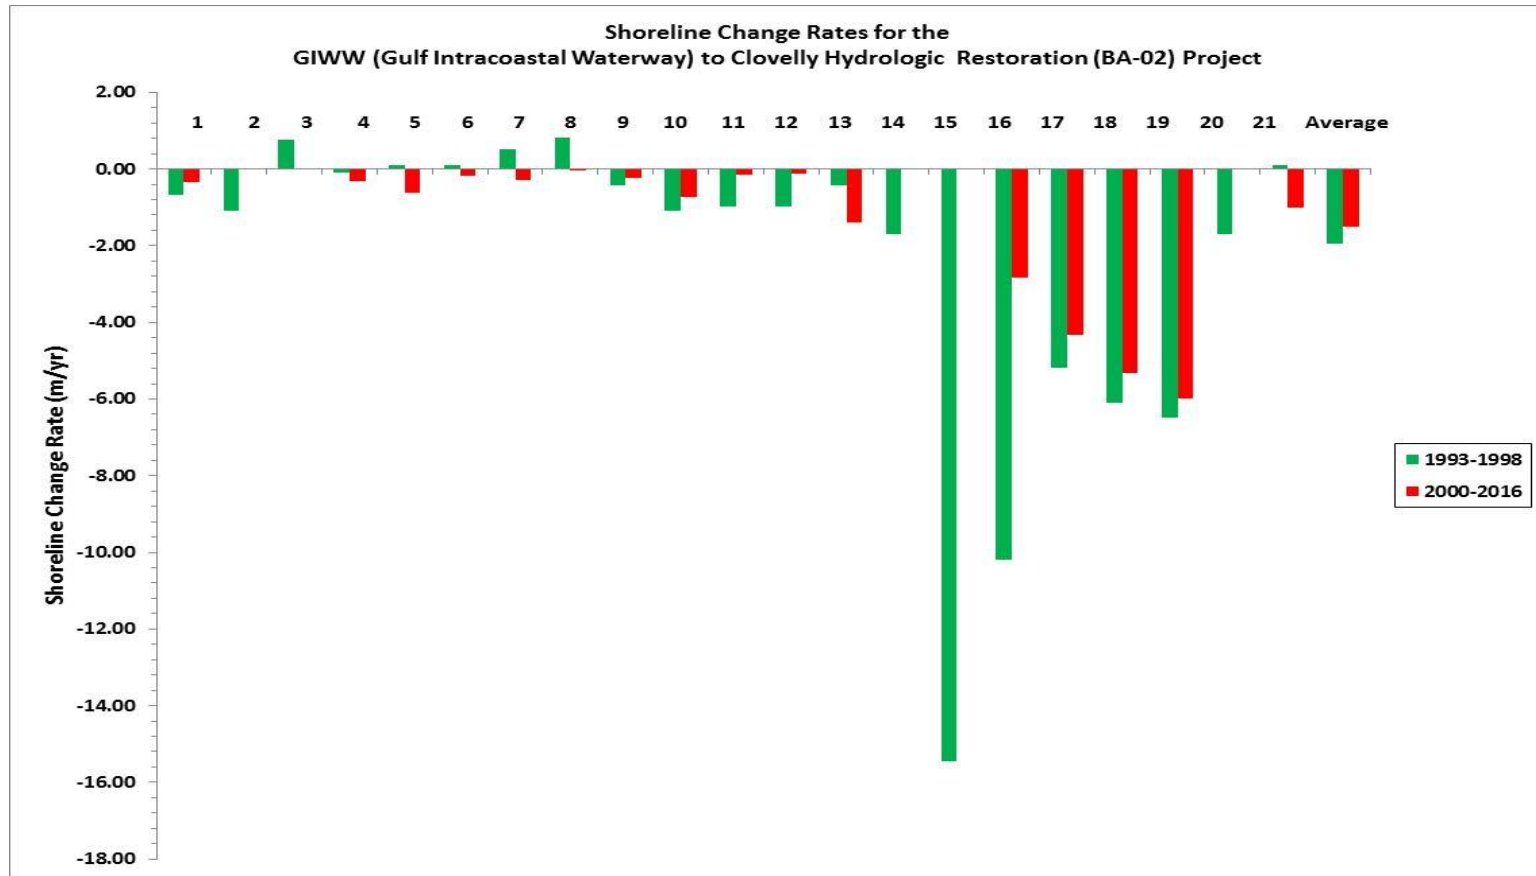
Figure 27. Shoreline change rates for each randomly selected shoreline segment pre- and post-construction, and the average shoreline change rate. Note: Construction ended October 31, 2000. Segments 2, 3, 14, 15, and 20 were not calculated into the “Average” change rate because there was no discernible continuous shoreline.

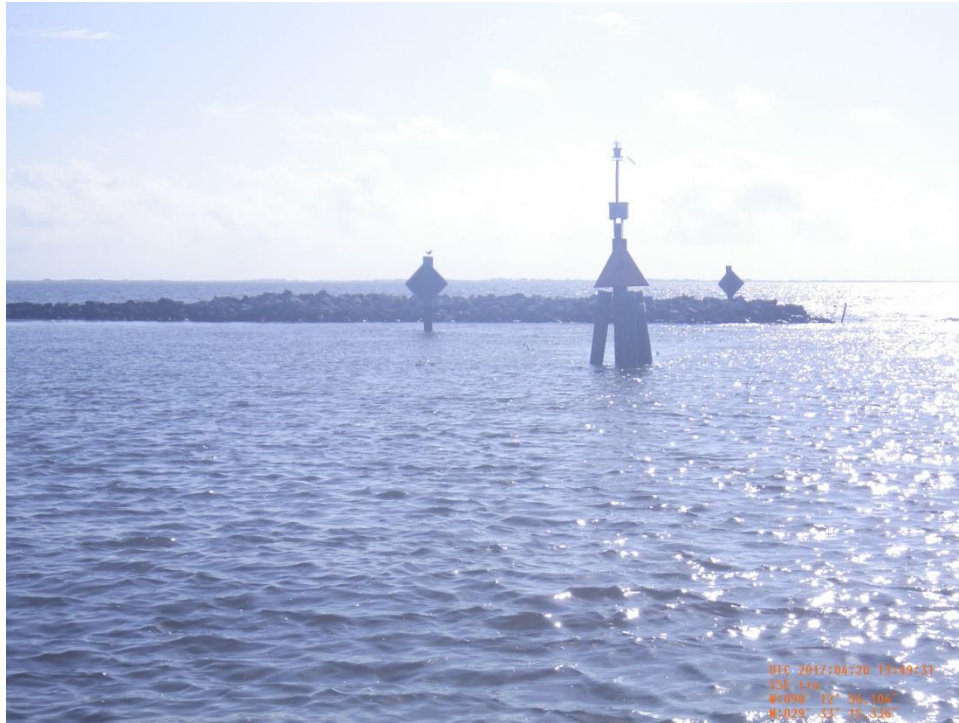
Photo No.1 – View of navigational aid and rock weir with barge bay across Clovelly Canal at Little Lake.

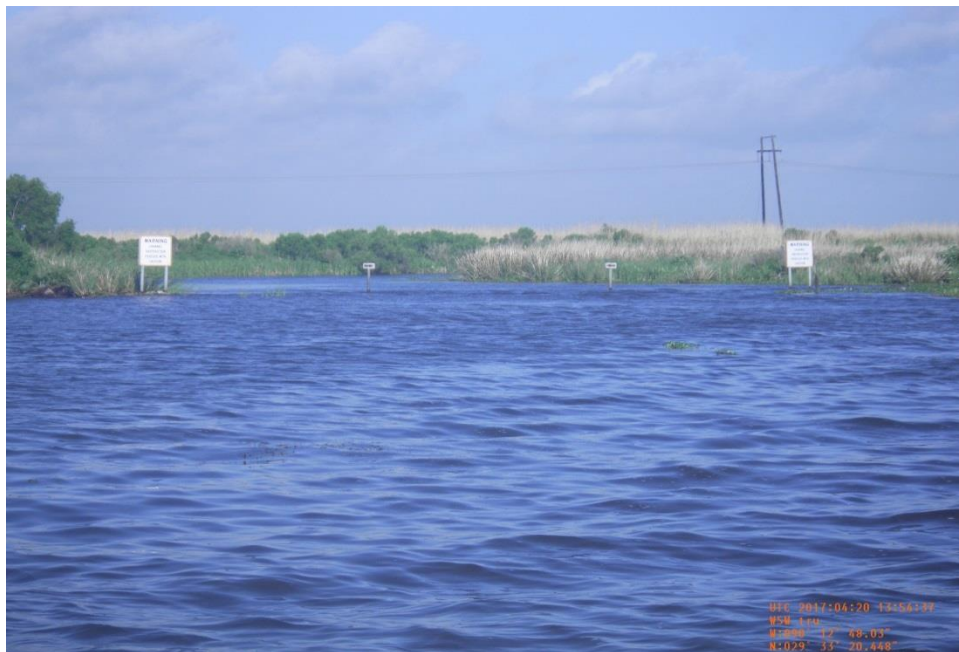
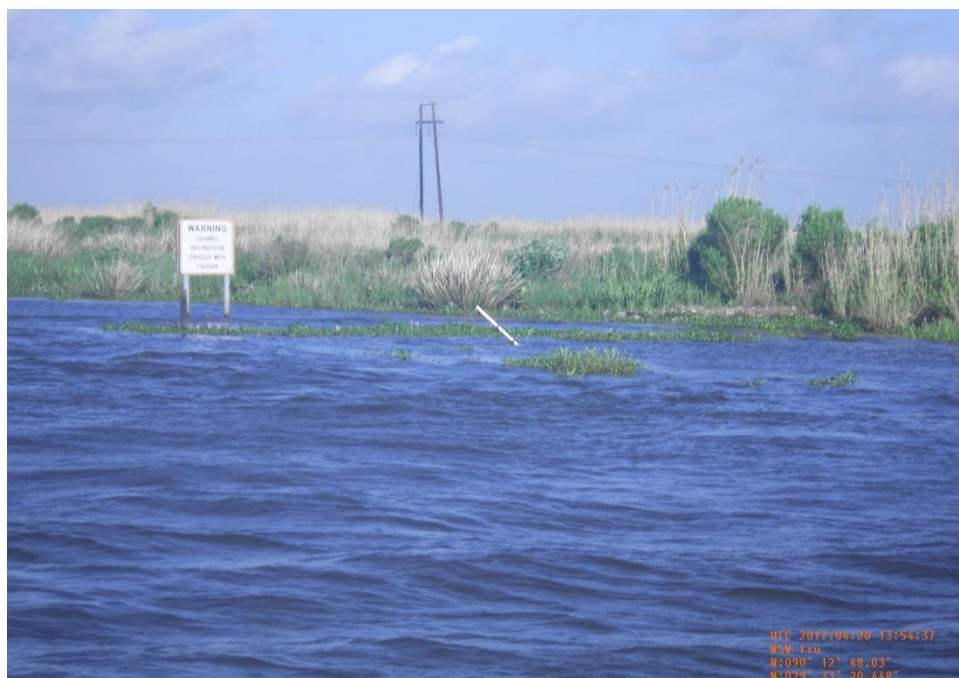
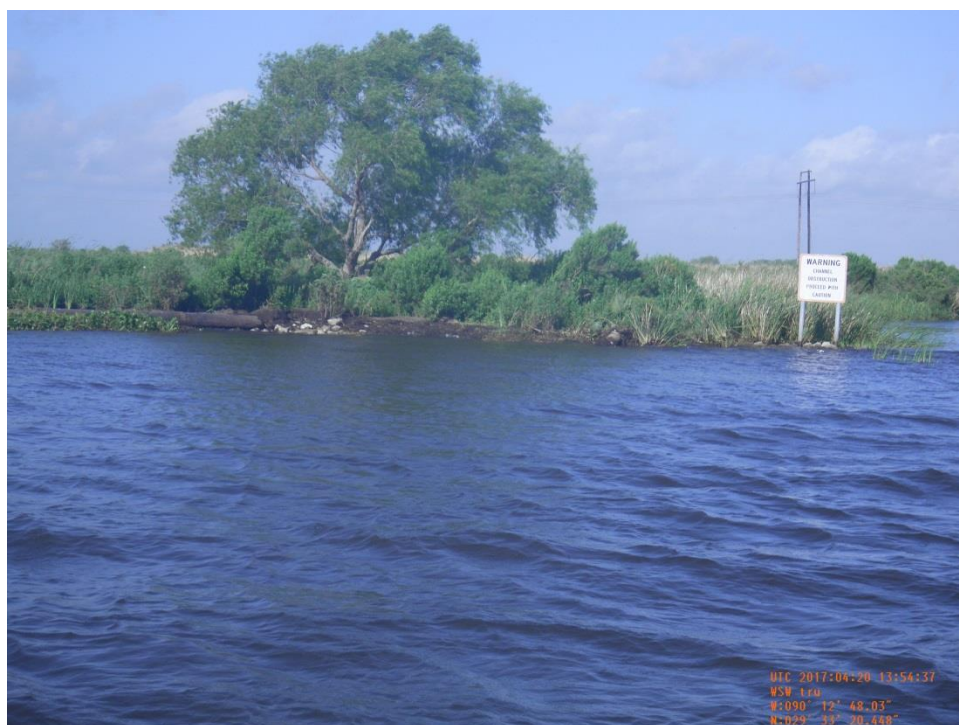
Structure 7 appeared to be in fair condition with noticeable settlement of the rock riprap material on each side of the boat bay. Based on water elevations from the CRMS station along Superior Canal, we estimated the crest elevation of the rock weir on both sides of the boat bay to be between 1.5 ft (0.46 m) and 1.6 ft (0.49 m). There was no visual damage to the weir or erosion around the embankment tie-ins. Soundings taken at the boat bay indicated a water depth of approximately 6.8 ft (2.07 m), which would correspond to an elevation of -5.2 ft (-1.58 m) NAVD88 after adjustments. The original as-built drawings show the crest elevation at the boat bay was constructed to -4.4 ft (-1.34 m) NAVD88. Settlement since construction of Structure 7 is estimated to be approximately 1.0 ft. We are not recommending maintenance of Structure 7 at this time. All warning and navigational signs and their supports appear to be in good condition. See Appendix A, Photos 5 through 7)

Photo No.5 – View of rock weir with boat bay (Structure 7) from Little Lake.

Photo No.6- View of the rock weir to shore tie-in on the north side of Structure No.7.

Photo No.7 – View of the rock weir to shore tie-in on the south side of Structure No.7.

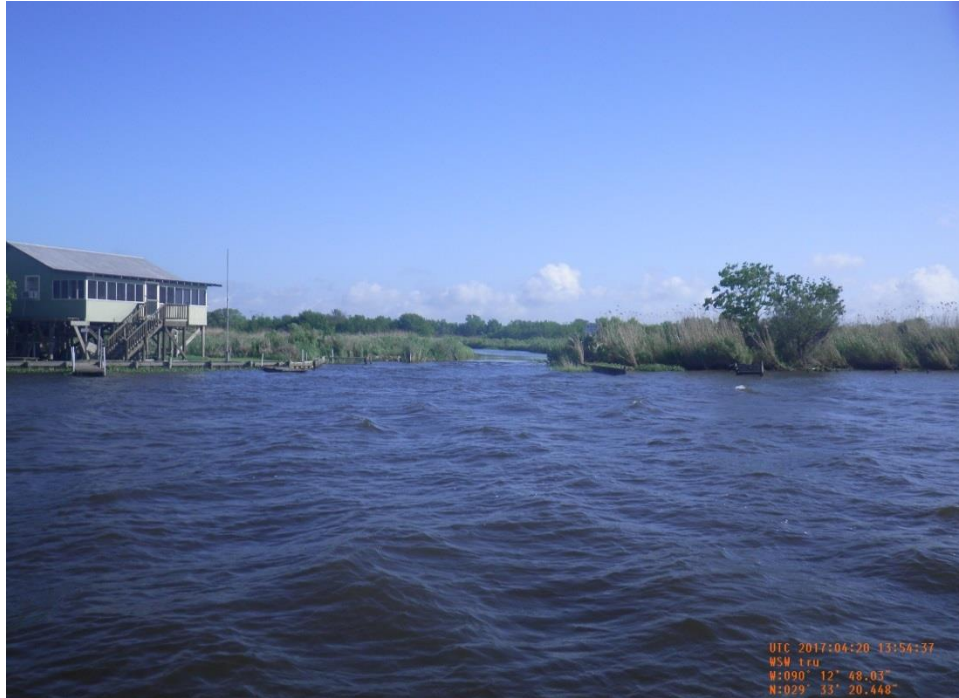
Structure 8 is a small rock weir with a boat bay located just north of Structure 7. The existing channel is very narrow and access is limited. From a distance, the structure appears to be in fair condition with minimal settlement of the riprap material and no erosion or washouts around the bank tie-ins. This structure was originally constructed with a steel gate to prevent access into the interior marsh, but this gate was destroyed during Hurricanes Gustav and Ike. The landowner had replaced the steel gate with floating barrels. Currently, the barrels are gone and the structure is open to access., There are no plans for maintenance of the structure or to replace the gate or barrels. (See Appendix A, Photo 8)

Photo No.8 – View of the small rock weir (Structure 8) along a channel from the interior marsh.

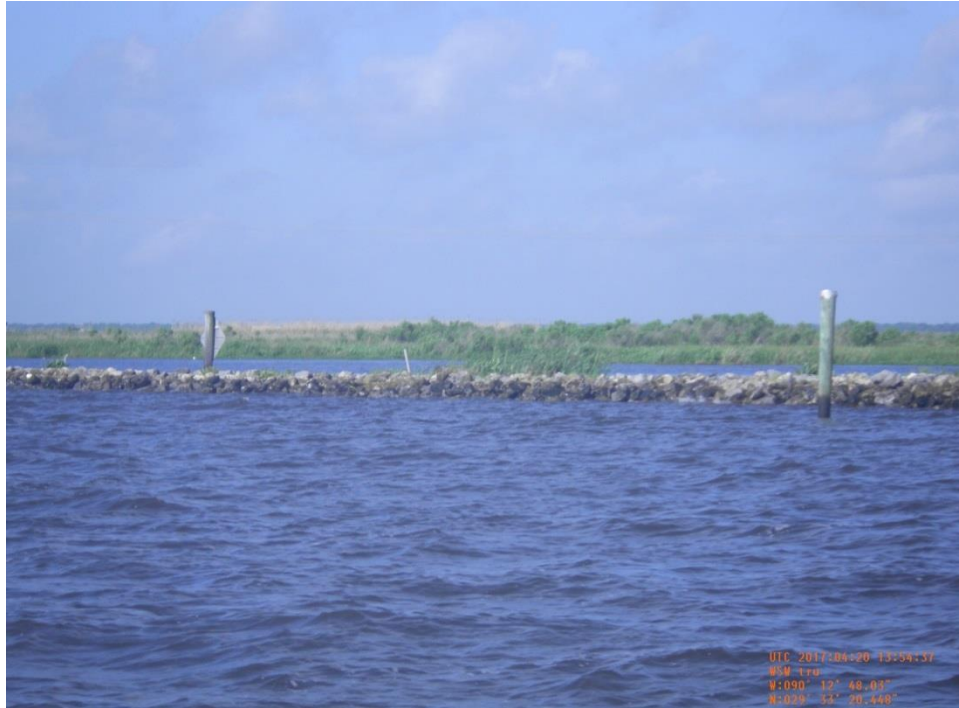
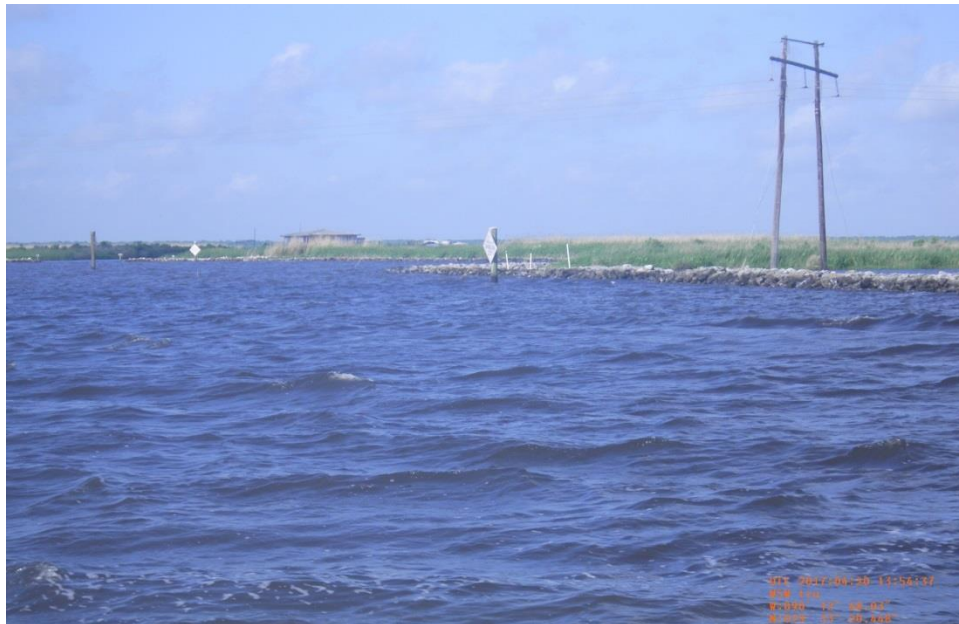
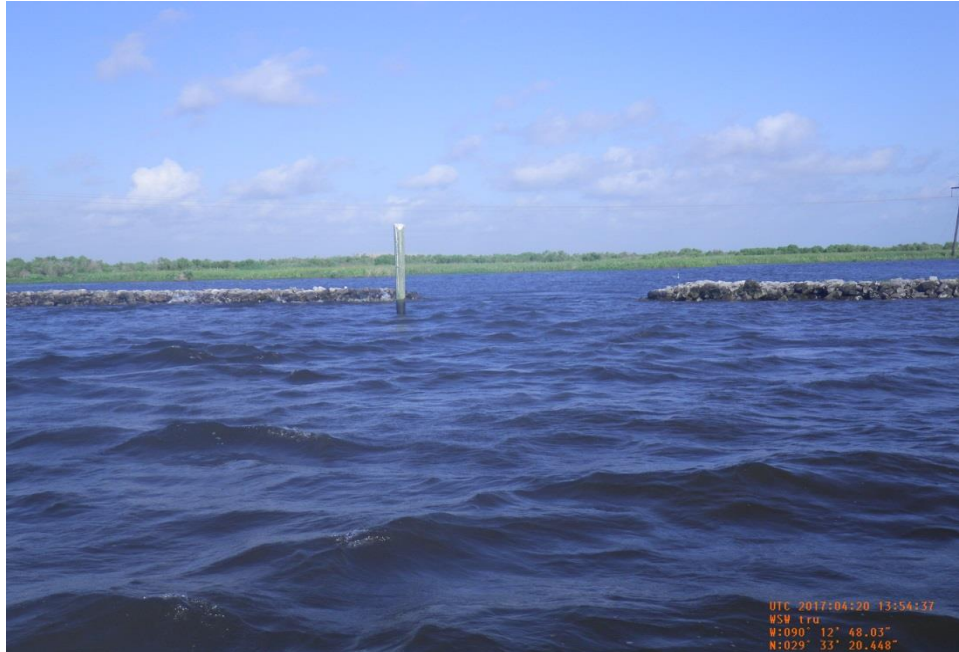
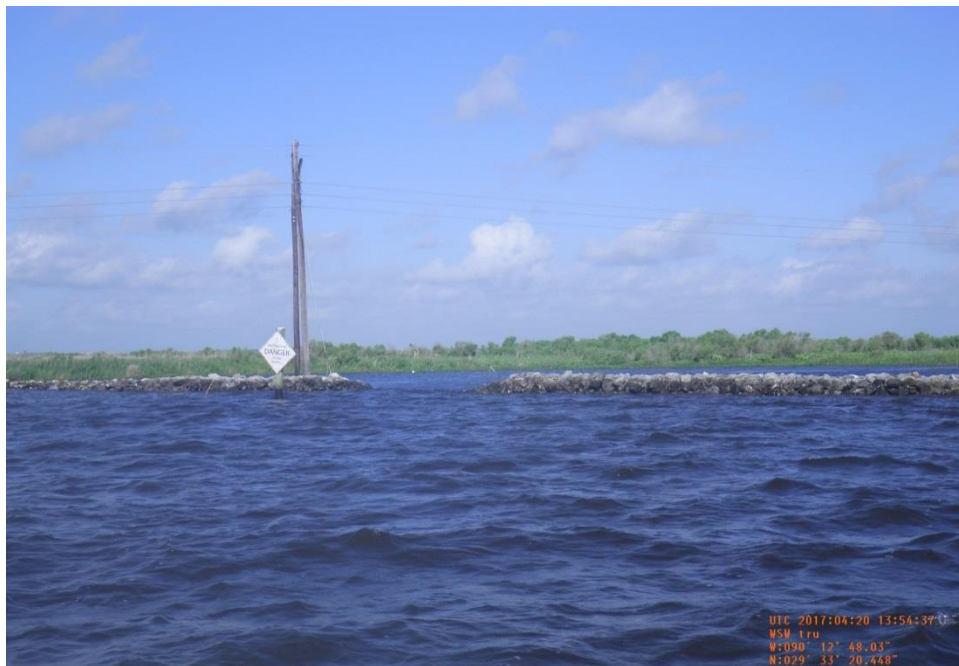
Structures 4A and 4B were recapped in 2012 to its original design elevation. A rock dike closure was also constructed from structure 4A to structure 4 to close a large opening in the marsh. The rock dike closure was approximately 1,000 linear feet long and was built to a +3.5 elevation. Structure 4A, 4B and the rock dike closure were all in good condition with little or no visual signs of settlement. We did notice erosion on the north side of structure 4B where the marsh has retreated. This is a normal occurrence where a hardened structure abruptly ends. As reported on previous inspections, the warning signs were damaged and deteriorated over time. CPRA replaced all of the signage along Structure 4A and 4B in 2017 under a multi-project maintenance event. (See Appendix A, Photos 9 through 13)

Photo No.10 – View of the rock plug (Structures 4A and 4B) along the shoreline of Bay L' Ours.

Photo No. 11 – View of the rock closure structure between Structures (4A/4B) and the rock weir with boat bay (Structure 4).

Photo No.12 – View of the warning sign at the fish dip along the rock closure structure between Structures 4A/4B and 4.

Photo No.13 – View of the warning sign at the fish dip along the rock closure structure between Structures 4A/4B and 4.

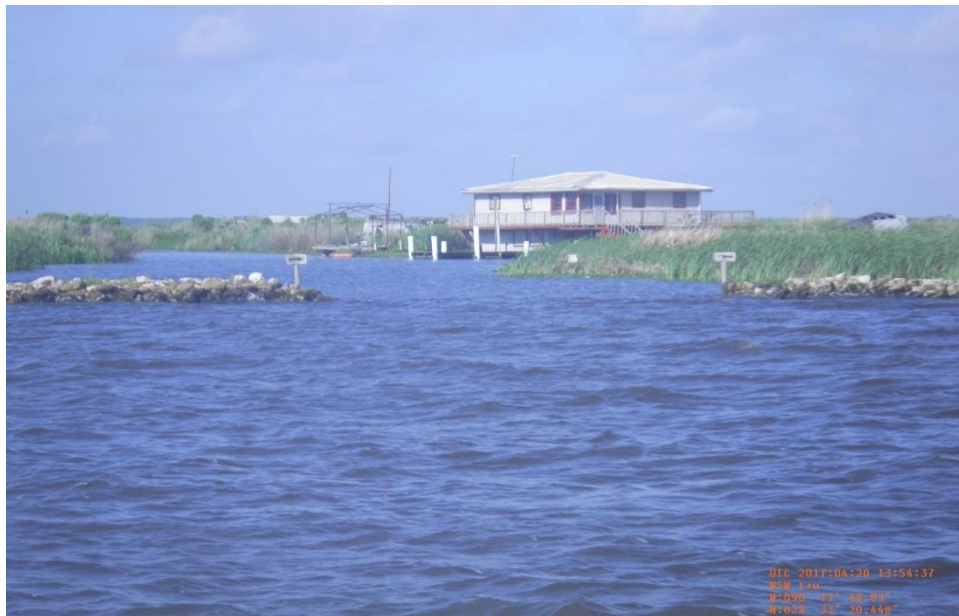
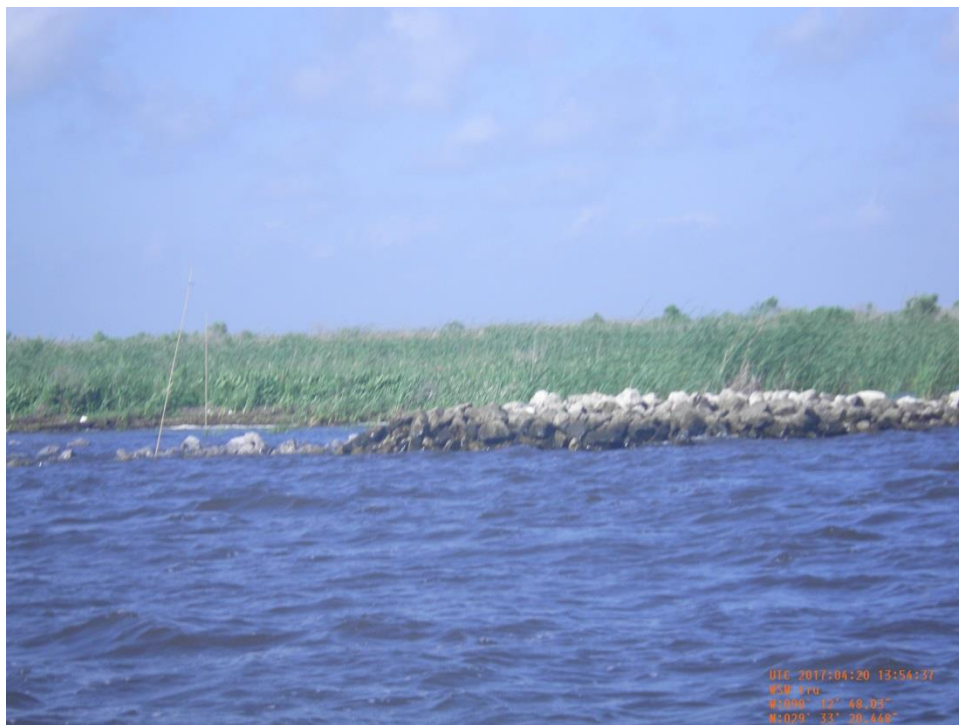
Structure 4 was also capped with riprap in 2012 to bring the crest to its original elevation. At the inspection, Structure 4 was in good condition with no visual signs of settlement or rock displacement. On previous inspections, it was noted that the marsh on the southern tie-in continues to erode and has detached from the rock weir. The southern tie-in has been repaired and the rock dike extended along the shoreline to connect to structure 2 under the 2015 Maintenance Project. It was also noted previously that the warning signs have deteriorated and need replacement. CPRA completed a multi-project sign replacement project in 2017 which included signs along Structure 4 and 4A of the GIWW to Clovelly (BA-02) project. (See Appendix A, Photo 14 and 15)

Photo No.14 – View of the rock weir with boat bay at Structure 4 from Bay L’ Ours.

Photo No.15 – View of the southern end of Structure 4 and new dike under construction.

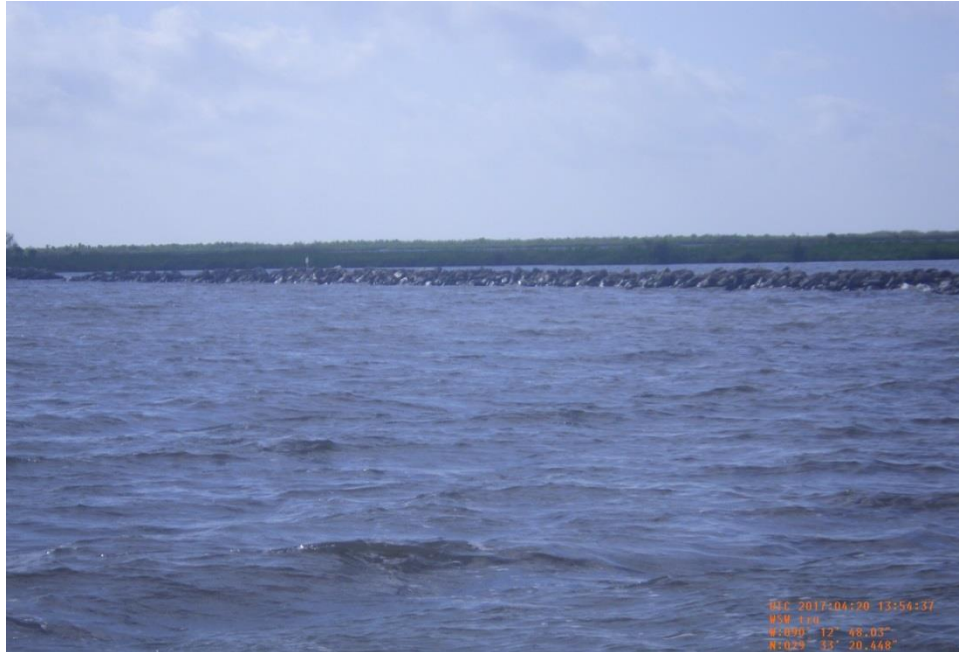
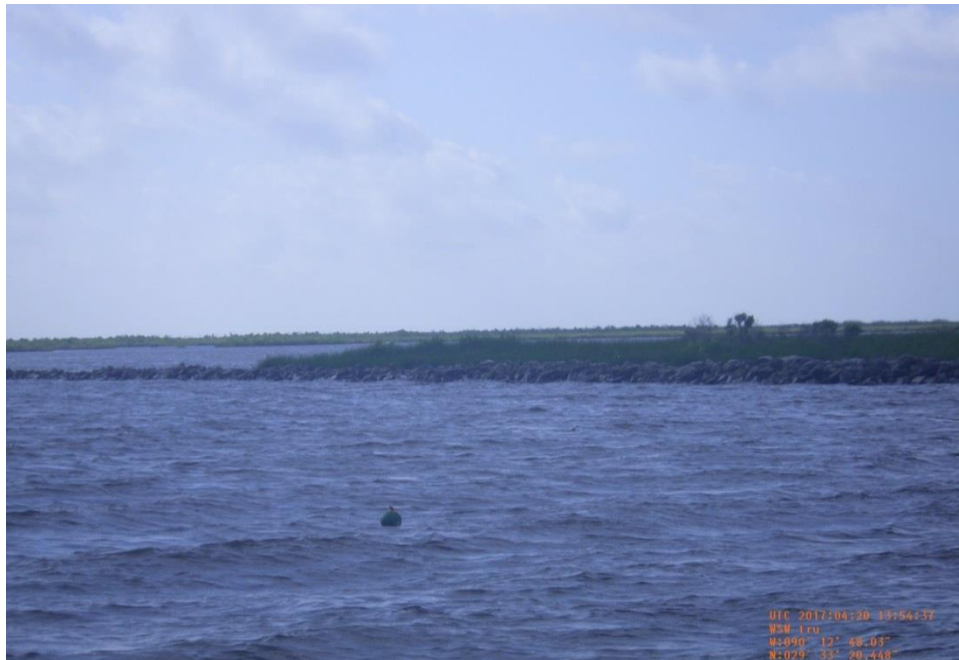
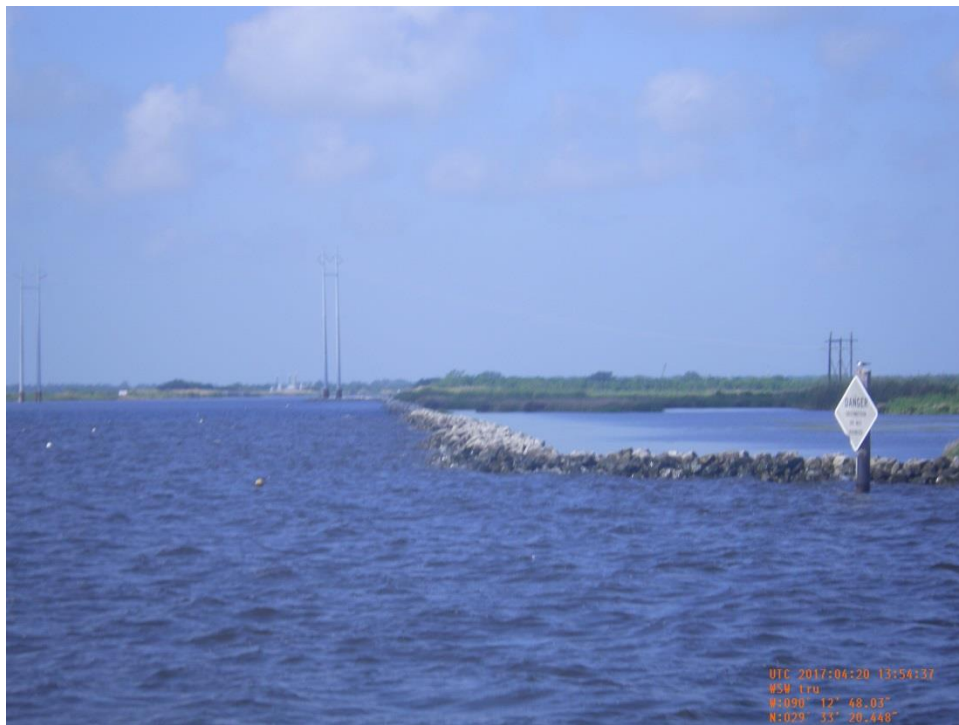
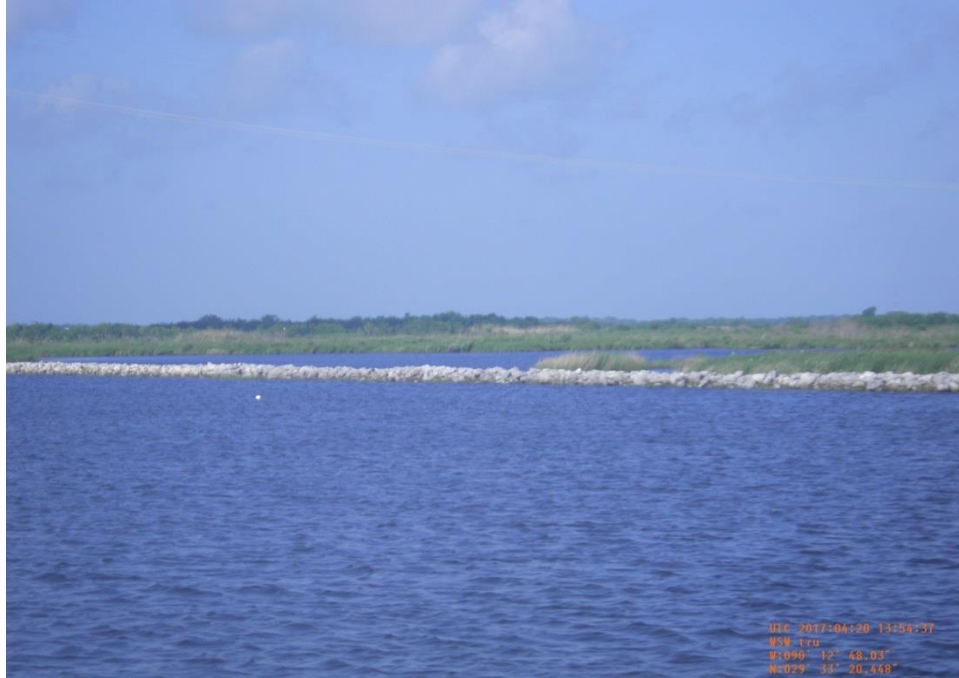
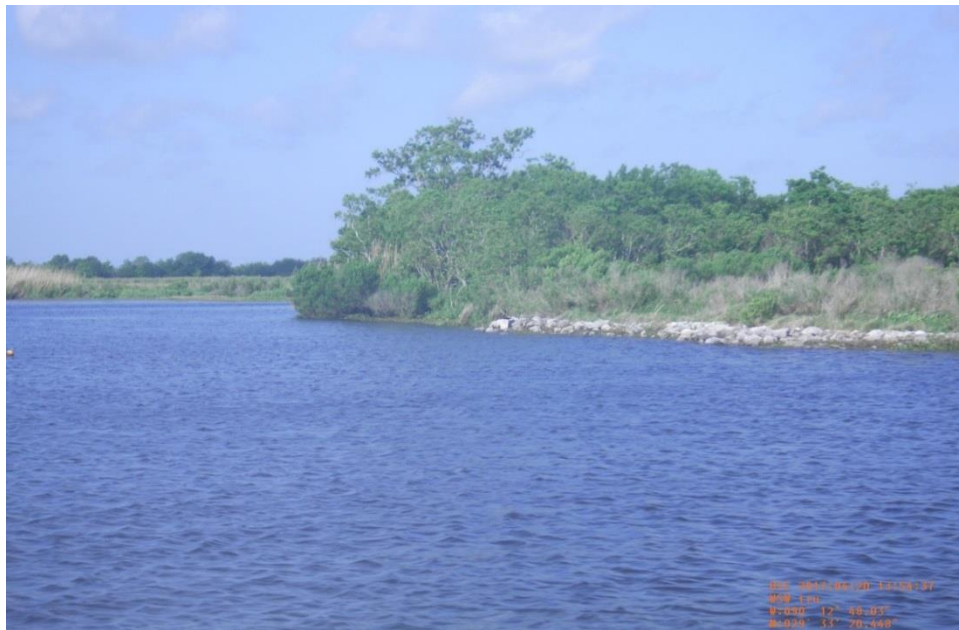
The Lake Rim structure was also refurbished in 2012 and appeared to be in good condition. The existing rock structure was recapped to a crest elevation of +3.5 to +4.0 ft along the north bank of Breton Canal and Bay L'Ours to structure 2. There are no visual signs of settlement or displacement of the rock along the structure and the warning signs are in good condition. There are no recommendations for maintenance at this time. (See Appendix A, Photos 18 through 25)

Photo No. 20 – View of the shoreline protection (lake rim) between Structure 2 and Breton canal.

Photo No. 21 – View of the shoreline protection (lake rim) between Structure 2 and Breton canal.

Photo No. 23 – View of the shoreline protection (lake rim) along Breton Canal.

Photo No. 24 – View of the shoreline protection (lake rim) along Breton Canal.

Photo No. 25 – View of the north termination of the shoreline protection (lake rim) along Breton Canal.

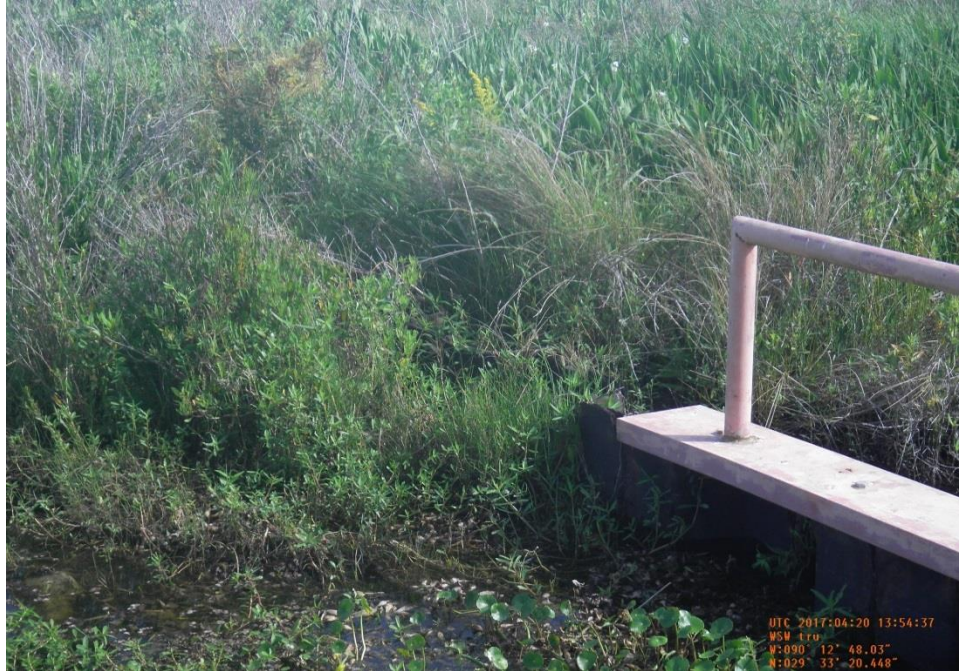
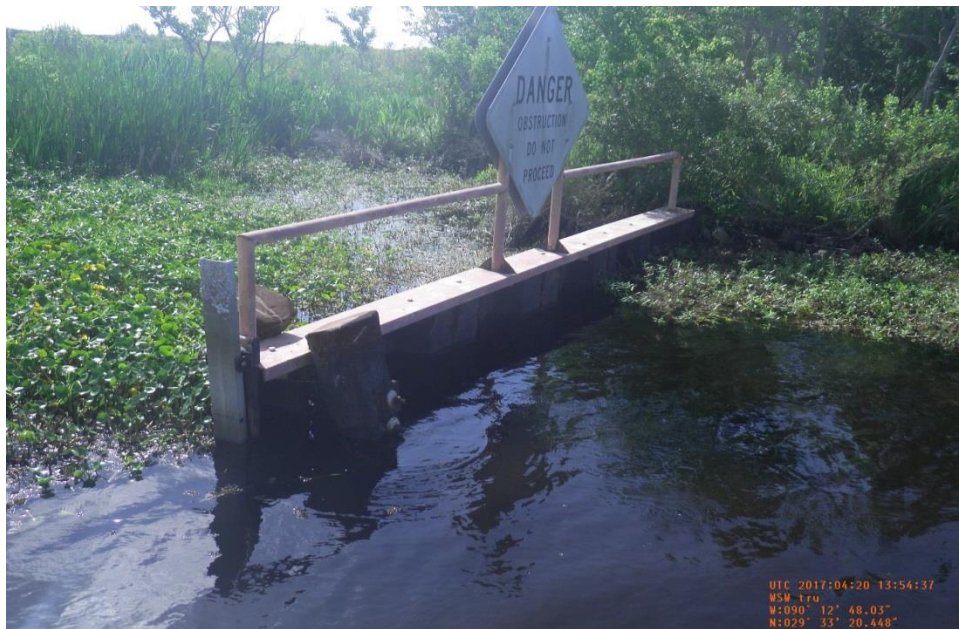
Overall, structure 35 has moderate corrosion on the bulkhead cap, handrails and deck. The stop logs, cables, signs and supports appear to be in good condition and operable. At the time of inspection the channel from the weir to the interior marsh was open and there appeared to be adequate flow through the interior marsh and structure. The embankment tie-ins also appear to be

in good condition with no erosion or washouts. We are not recommending any repairs or corrective actions at this time. (See Appendix A, Photos 26 through 29)

Photo No.28 – View of the sheet pile wall tie-in to bank on the north side of Structure 35.

Photo No.29 – View of the stop log bay and sheet pile wall tie-in to bank on the south side of Structure 35.

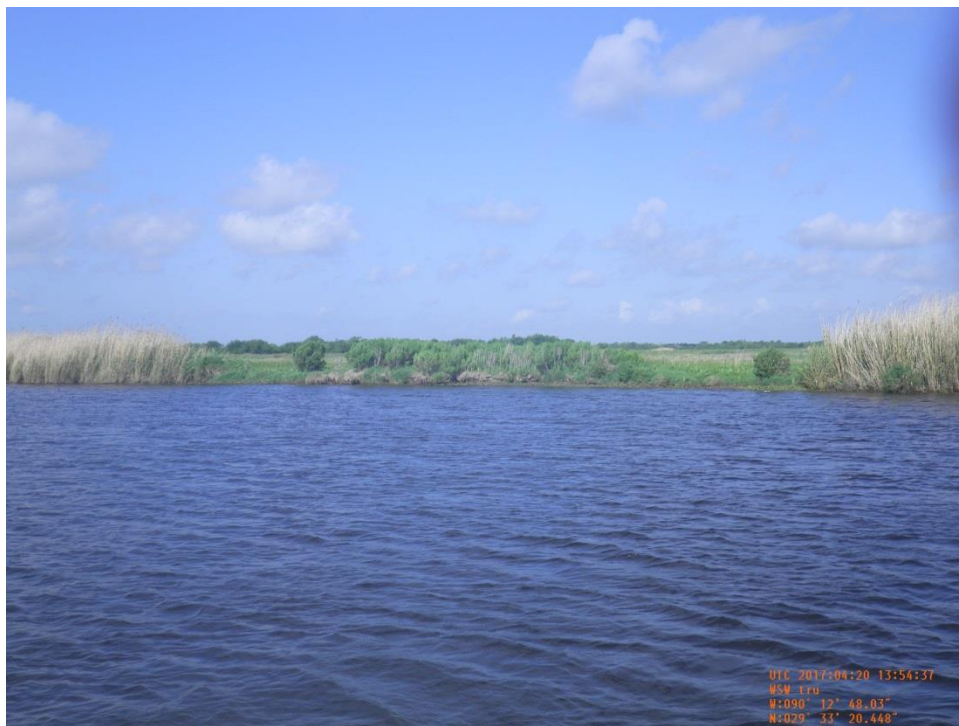
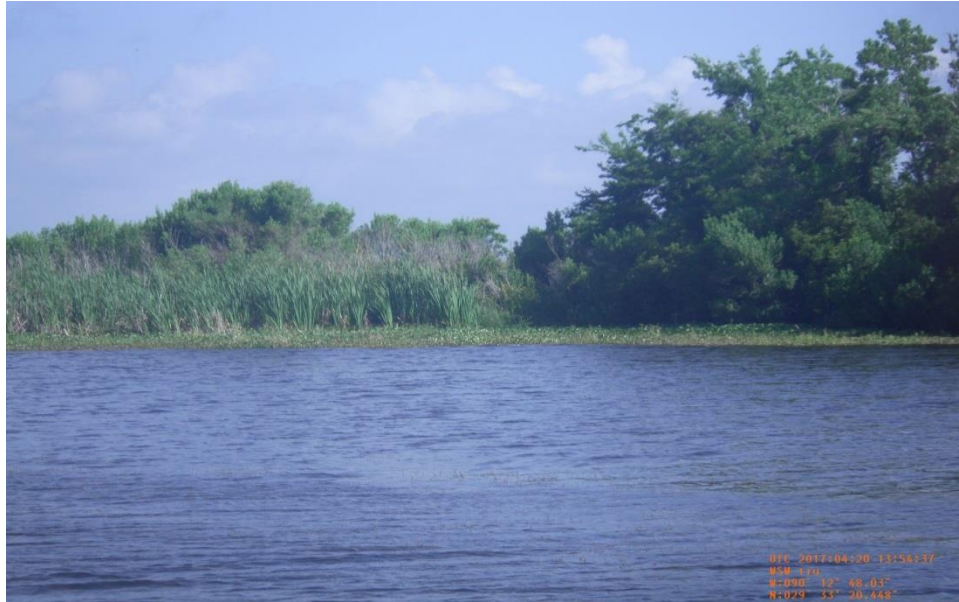
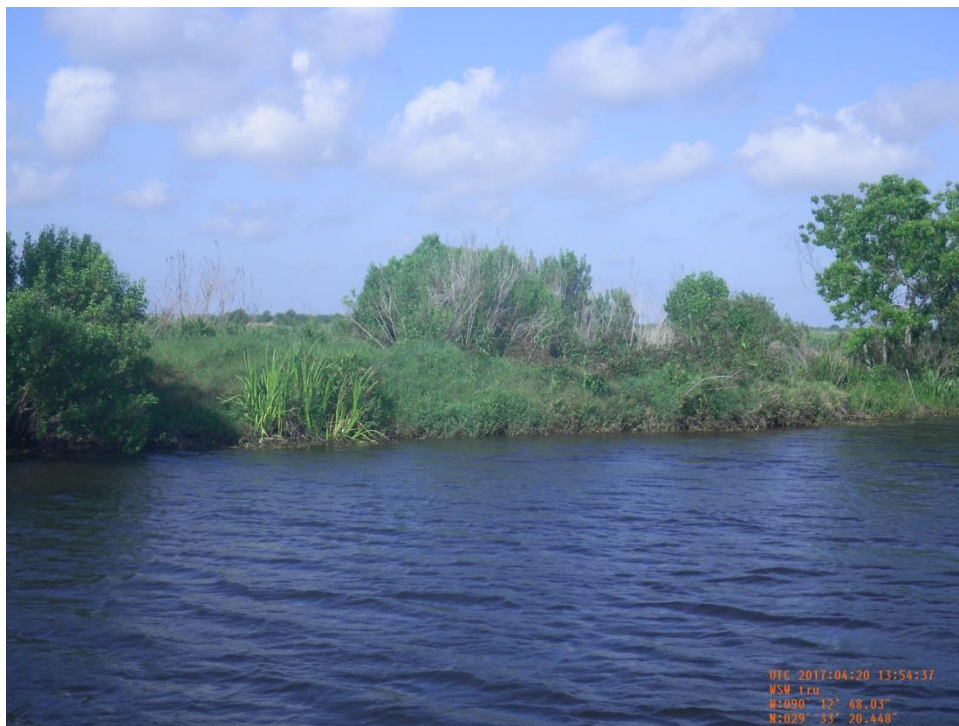
There were five (5) breaches repaired in the 2012 Maintenance Project. Breach 1 was located along the north bank of Breton Canal just southwest of the first location canal from Bay L' Ours and was approximately 20 ft wide. Breach 2 was located along the northeast bank of the second location canal north of Breton Canal and was approximately 10 ft wide. Breach 3 was located on the south bank of the same location canal as breach 2 and was approximately 25 ft wide. Breach 4 was located on the west bank of an oilfield canal that intersects Breton Canal east of structure 1 and was approximately 30 ft wide. Another breach, designated as breach 5, was discovered at the end of a dead end oilfield slip south of breach 4. The breaches were closed by using material from the adjacent canal bottoms to reconstruct the earthen dike. The material was allowed to dry before it was shaped, seeded, and fertilized. All breach repairs appear to be in good condition with no signs of settlement or erosion. We did note a large breach along the north bank of Breton Canal east of breach repair 1. (See Appendix A, Photos 30 through 33)

Photo No.31 – View of the breach repair performed in 2012 along the north bank of Breton Canal.

Photo No.32 – View of breach repair along north bank of second location canal from Bay L' Ours.

Photo No.33 – View of breach repair along south bank of second location canal from Bay L' Ours.
